REFERENCES- OLEK LEJBZON & CO.

METAL WORK RESTORATION; WINDOWS, DOORS, HARDWARE, LIGHTING

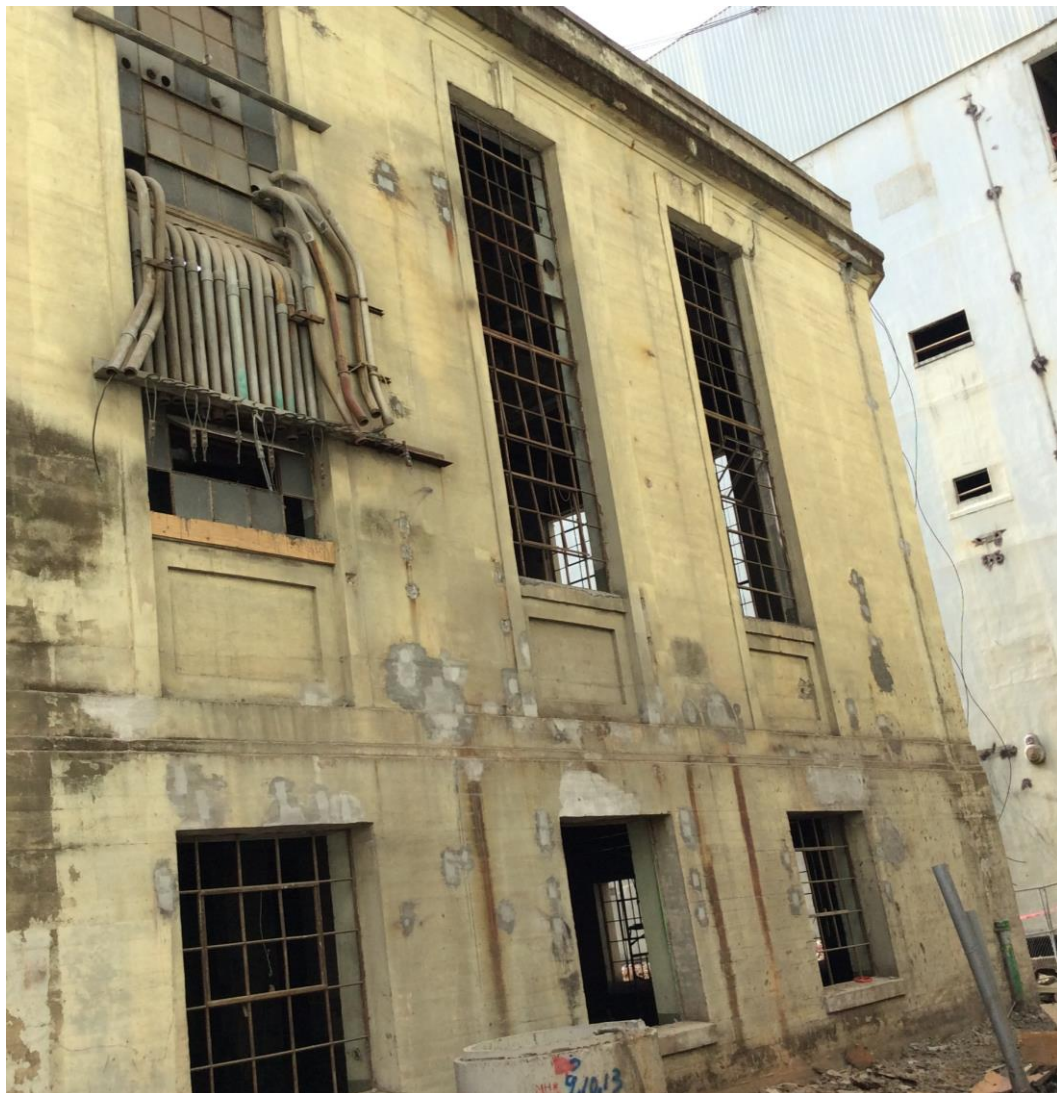
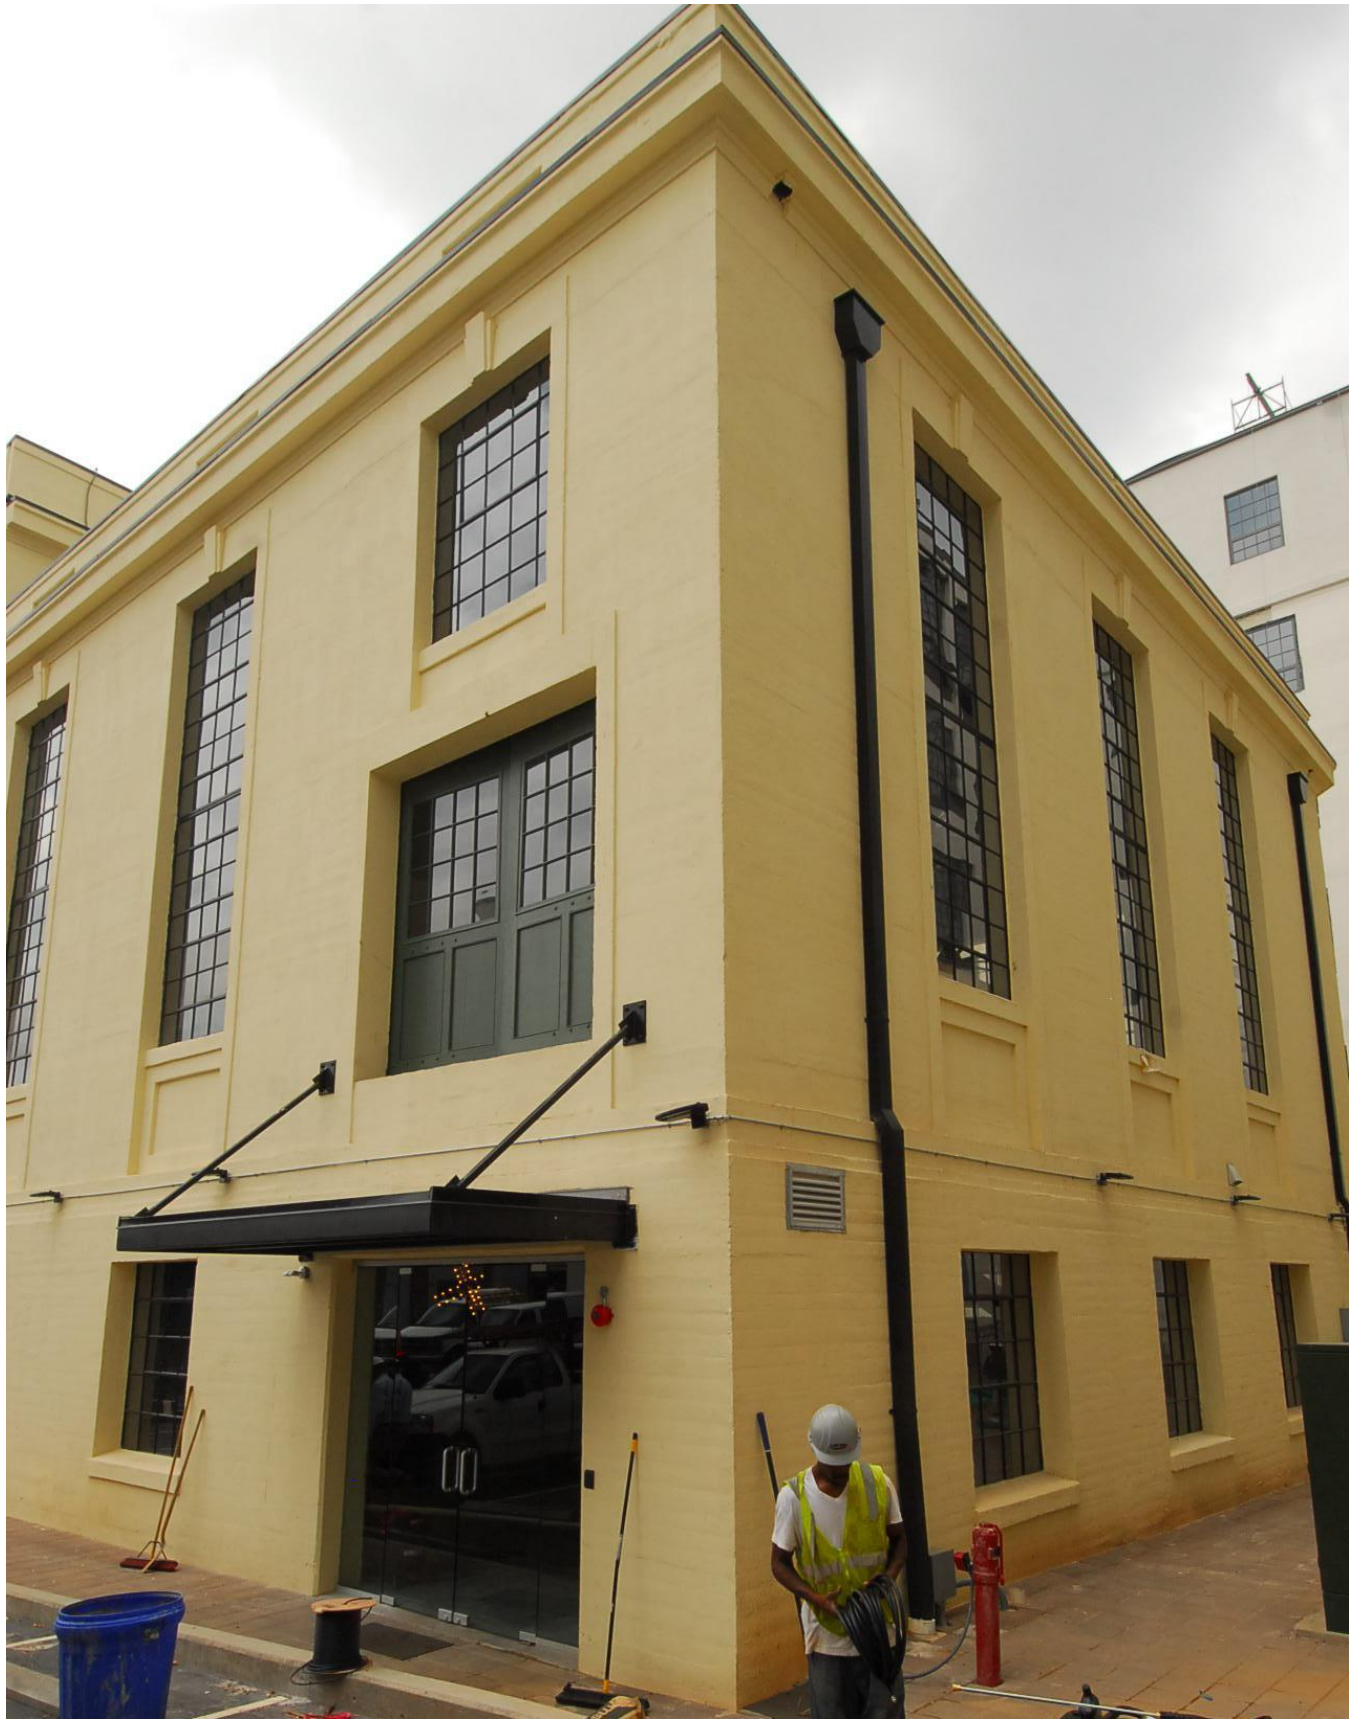
National Landmark Building required restoration per Secretary of the Interior's Guidelines. Windows had been mangled by gut demolition of the building's interior, concrete and machinery debris discarded through the existing window sashes and frames. Restored for new residential/commercial development, work approved by National Park Service. Custom replication of all profiles of two different factory window systems, by machining cove and beveled profiles in Olek's machine shop. Removing existing concrete and brick as needed to re-set steel window frames into masonry. 42 windows, up to 6'W x 18' H, \$167k 2014

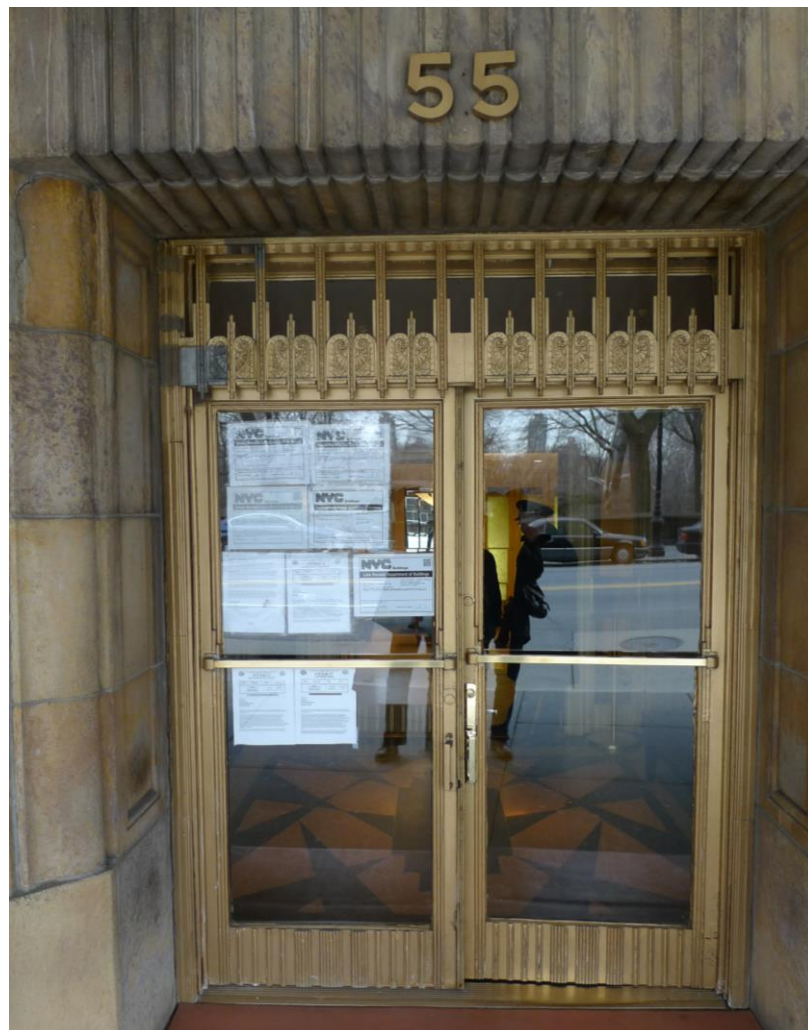
New Door astragal to left, brass "skyscraper" trim to right/ Machining trim moldings

Original architectural steel door frames embedded over 1’ deep between 1” thick marble slabs, salvaged from between original two sided marble paneled lobby without damage to marble. Existing bronze and aluminum trim restored. Original cast iron “skyscraper” trim replicated in bronze, by custom fabricating milling machine tooling, worn and damaged original elements replaced. Other entries for this building with approximately 150 apartments and professional offices at ground floor replaced with similarly replicated patterns. Door frames leveled and re-set plumb into original marble paneling. Custom lockset mechanisms designed and machined to operate these 350 lb. door leaves with lever handles inside 2” x 2” stiles, unavailable commercially. Glass etched by sandblasting to match Art Deco “skyscraper” pattern in lobby and laminated. Restored without diverting traffic from single residential lobby at any time. \$220k. 2014 -15

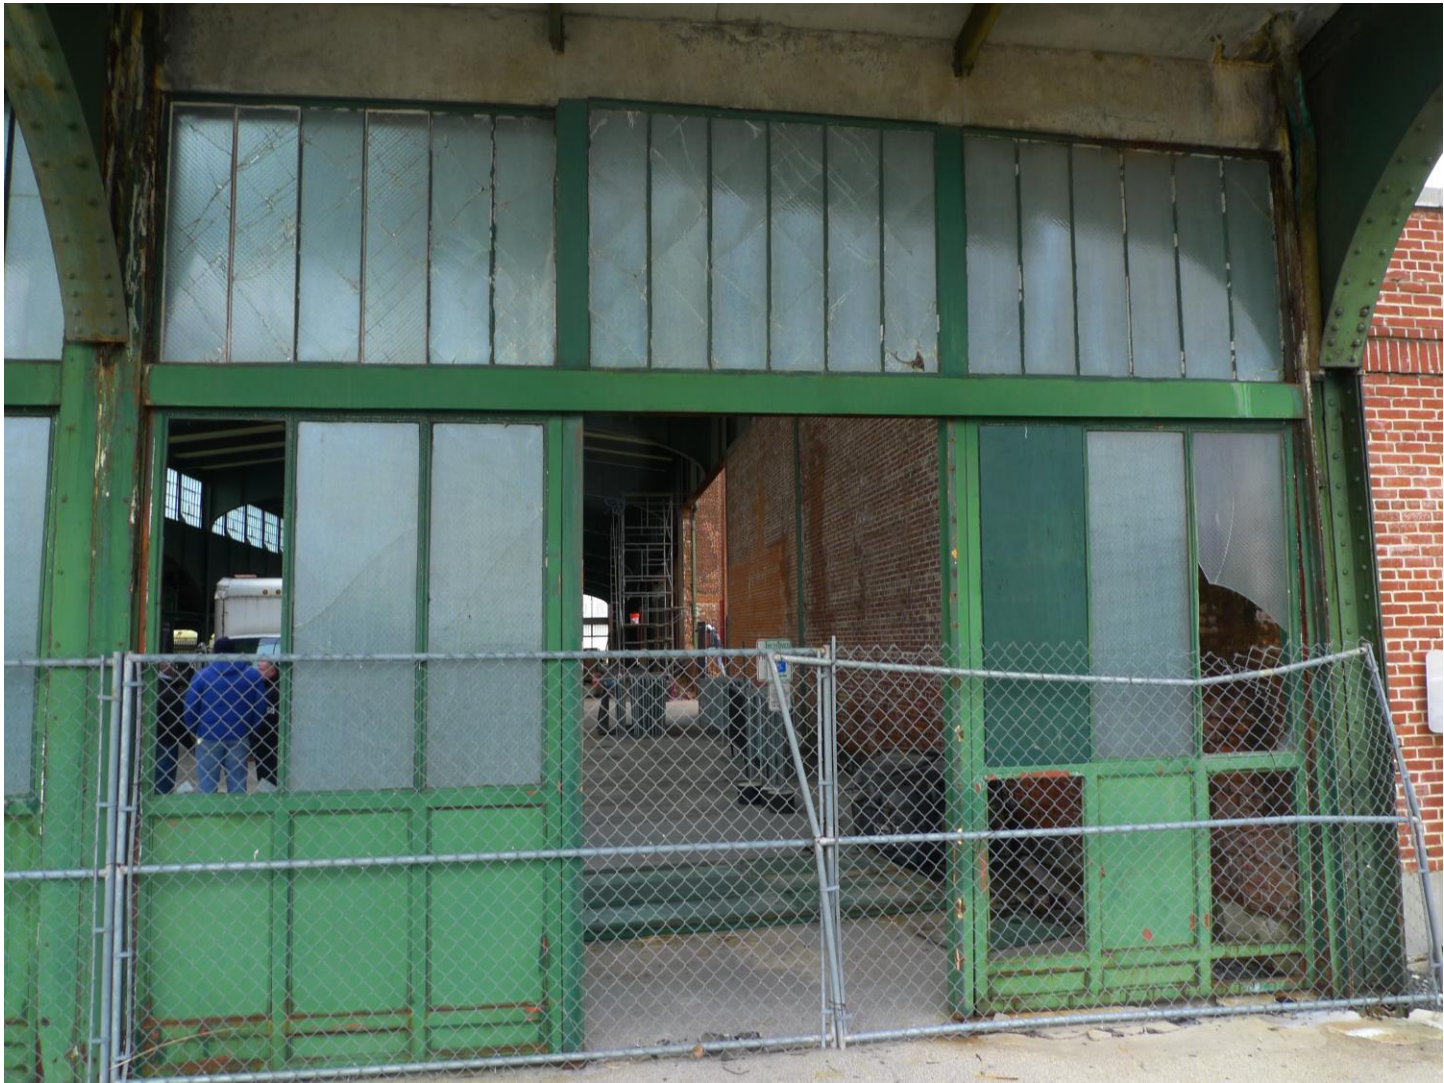
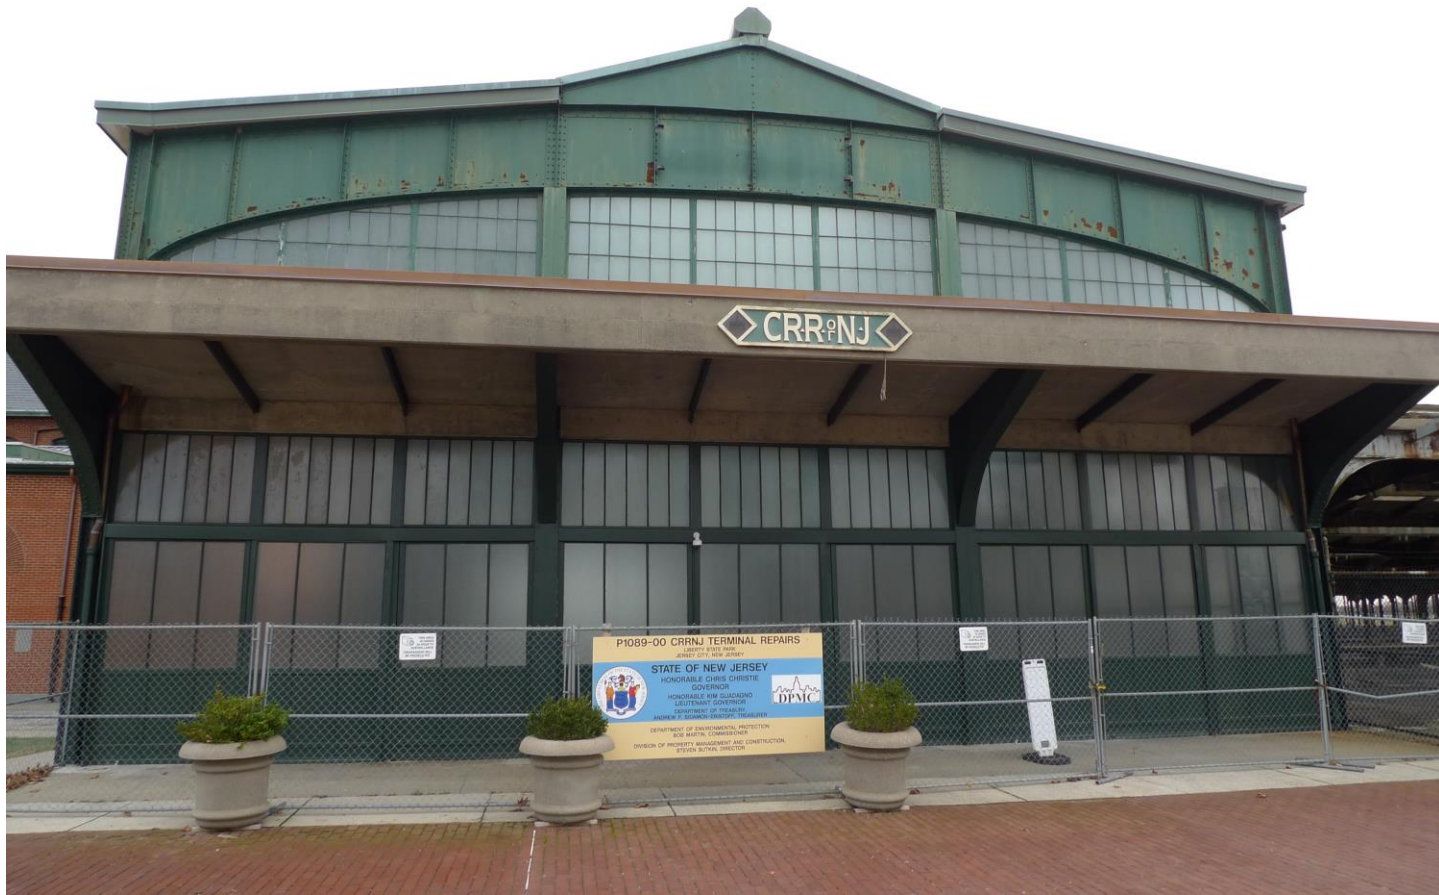
Landmark Station located on Hudson River, damaged heavily by Hurricane Sandy. Restored most of the original doors, and replicated several others. Restored hanging hardware, rebuilding it to be stronger than original using original hangar system, machining cast iron hanging door hardware to accept modern ball bearings as original system was too worn out to restore otherwise. Replaced glass with custom laminated glass, resembling original pebble pattern glass. \$210k 2014.

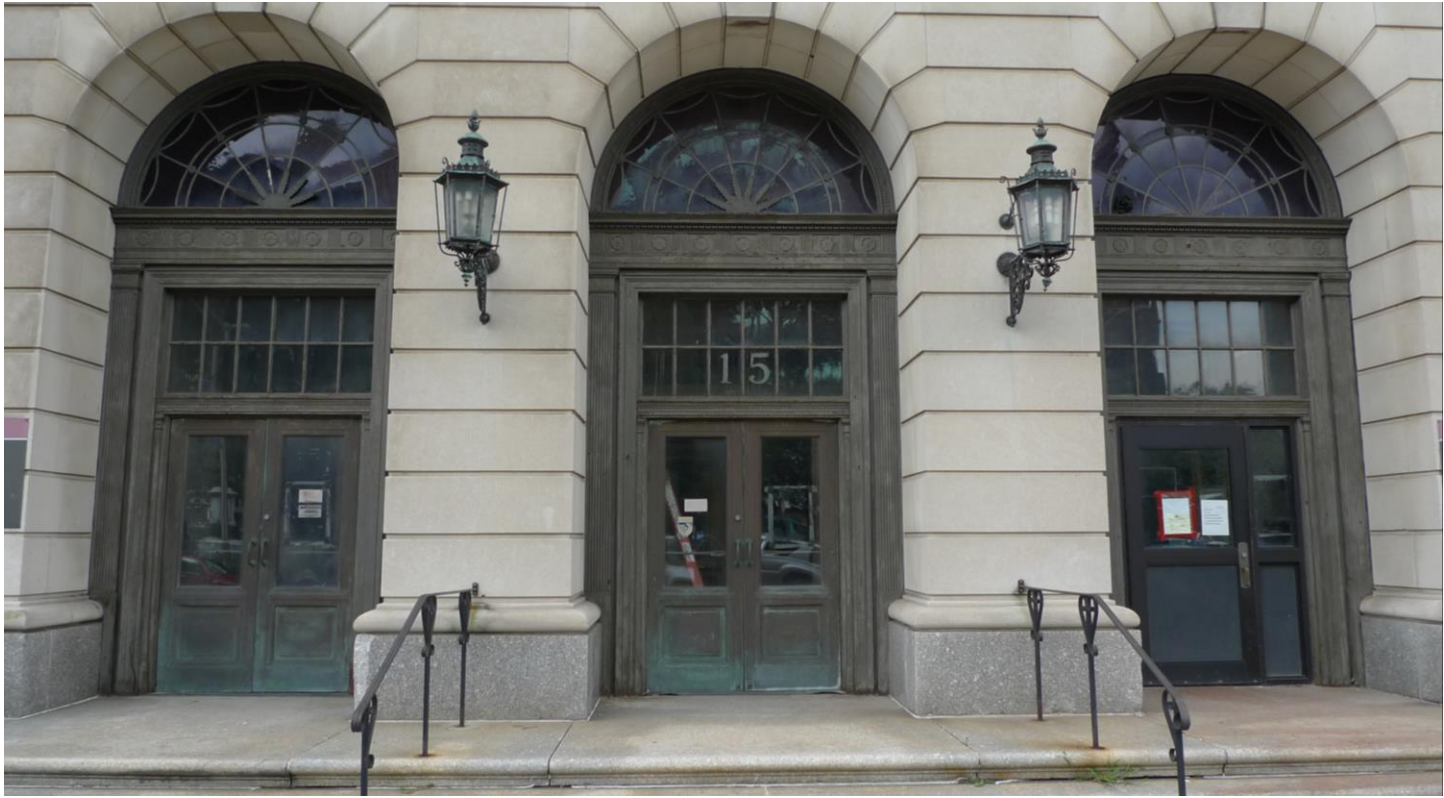
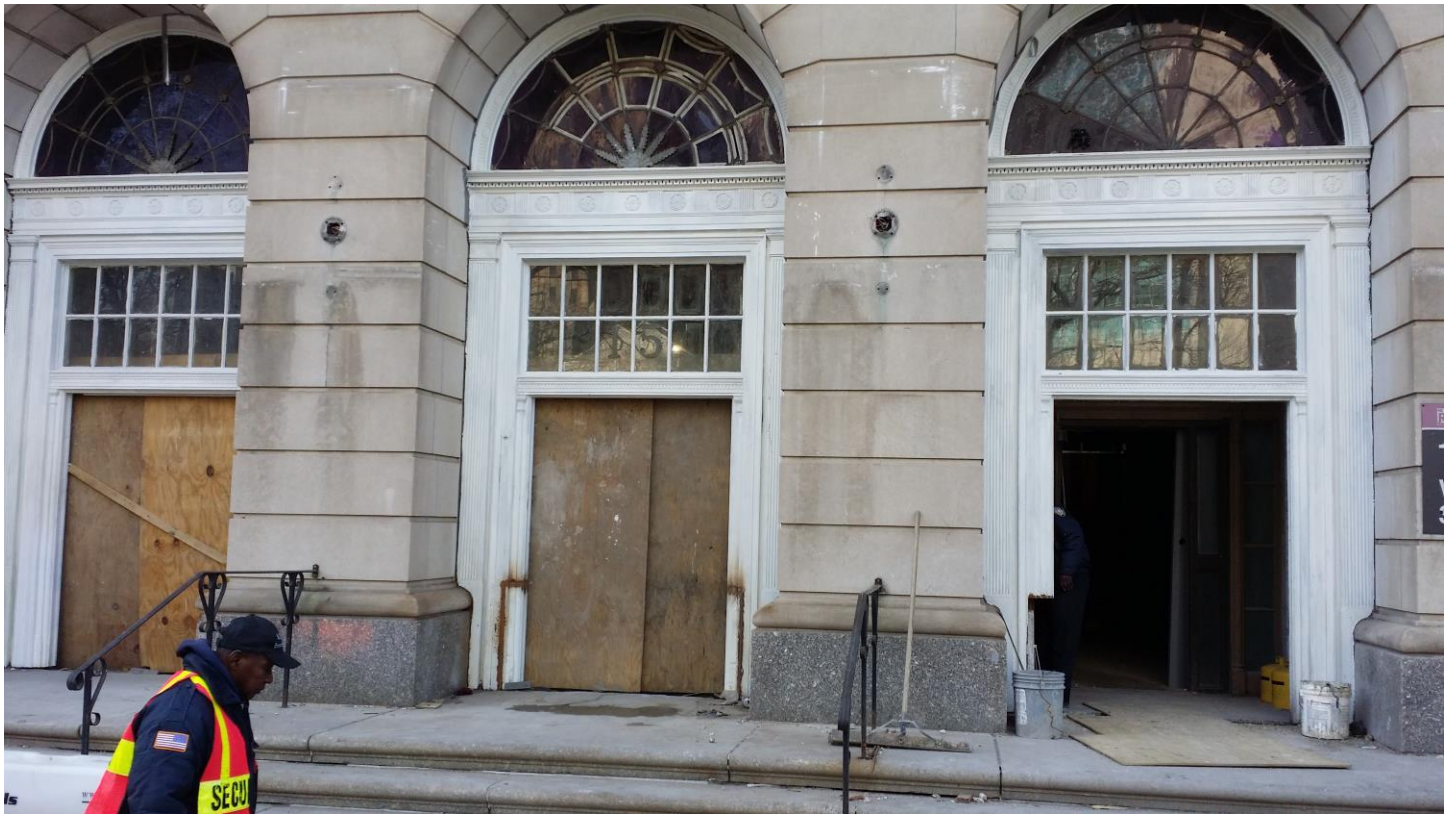
Door frames of 5/8” thick ductile cast iron damaged by chronic water infiltration and ice, splitting apart cast iron from granite sills, up over 24” high, and crushing brass doors 6’ wide by up to 1 ½” width. Restored all cast iron frames by cutting out damaged elements of jambs and trim, brazing and welding to original profiles, and restored two remaining pairs of exterior double doors, and revolving door, and lighting fixtures. \$127k 2015

Jambs all cut away over 2' high, repaired in shop, and welded back in place. Frames and lead fanlights stripped and frames repainted.

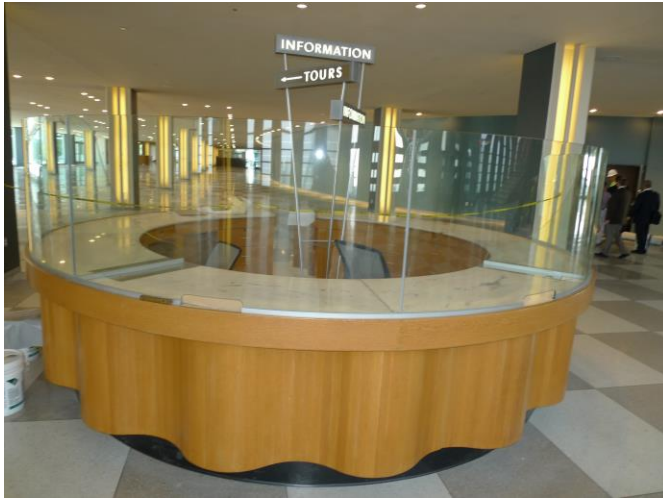
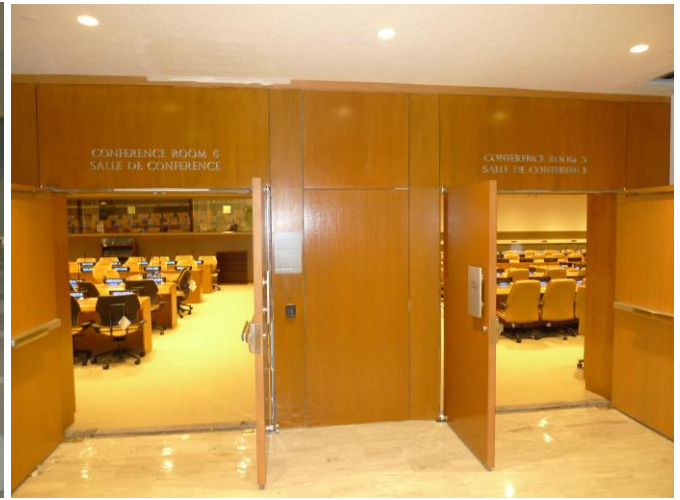
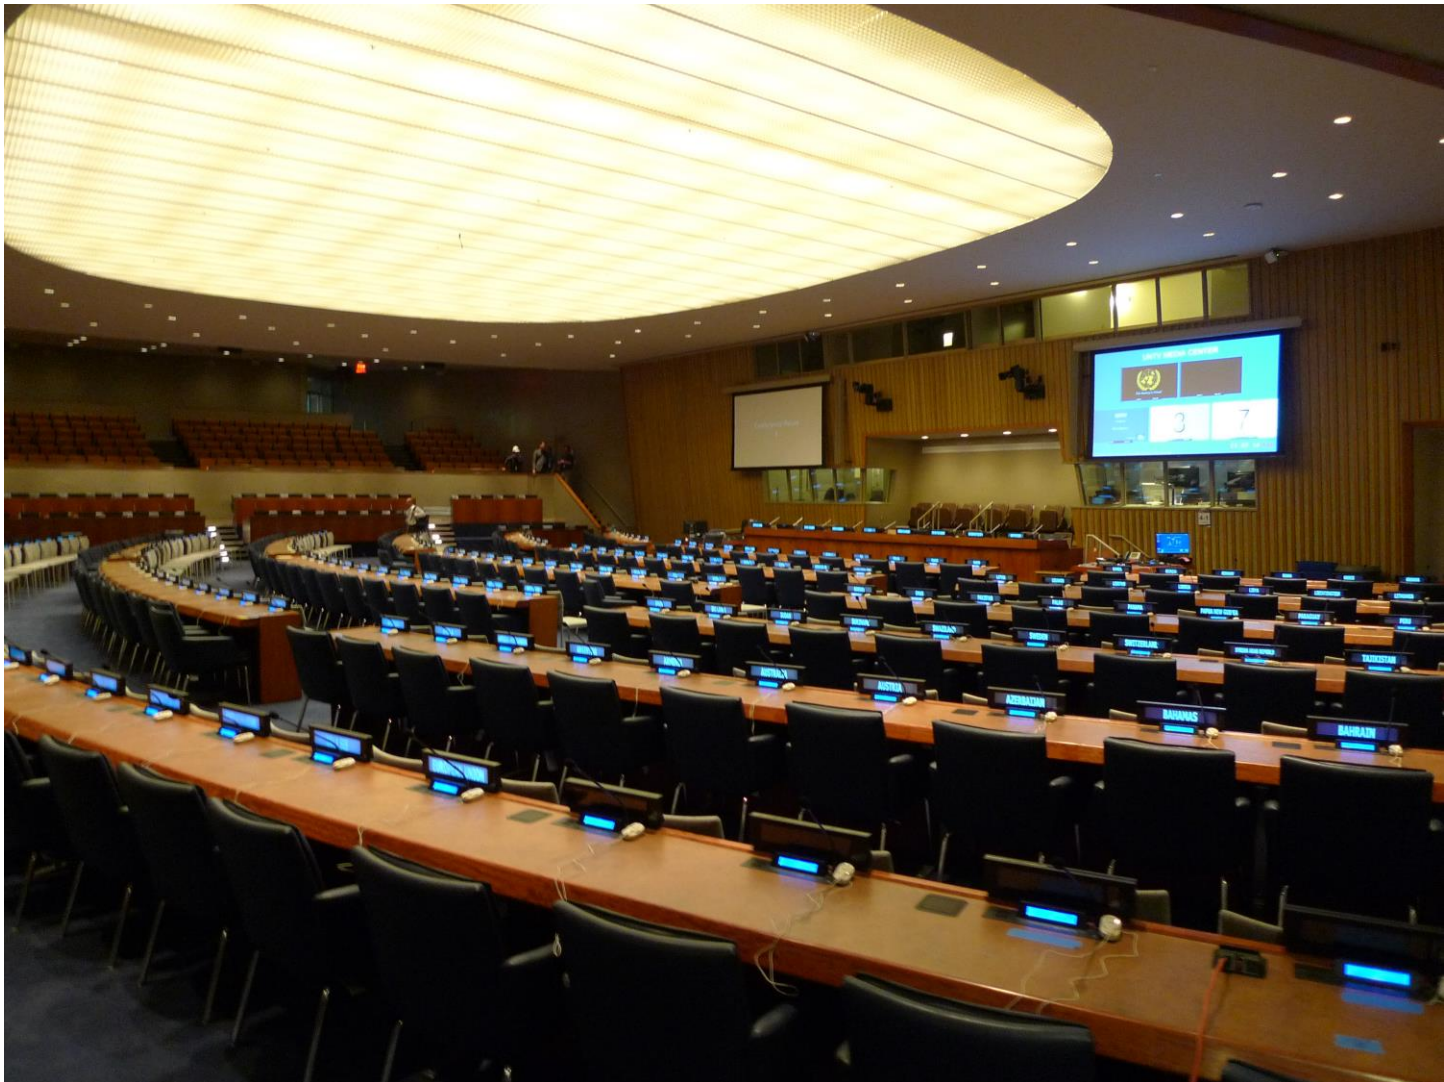
Fabrication of new steel bases and tables replicating vintage originals designed by Eero Saarinen and other prominent designers. Replication, Refinishing and restoration of metal hardware and components, and all wood furniture. \$1.4M 2014.
